# Capabilities and Application of Specialized Computed Tomography Methods for the Determination of Characteristic Material Properties of Fiber Composite Components

Michael Krumm<sup>1</sup>, Christoph Sauerwein<sup>1</sup>, Volker Hämmerle<sup>1</sup>  
Reinhold Oster<sup>2</sup>, Björn Diewel<sup>2</sup>, Manfred Sindel<sup>3</sup>

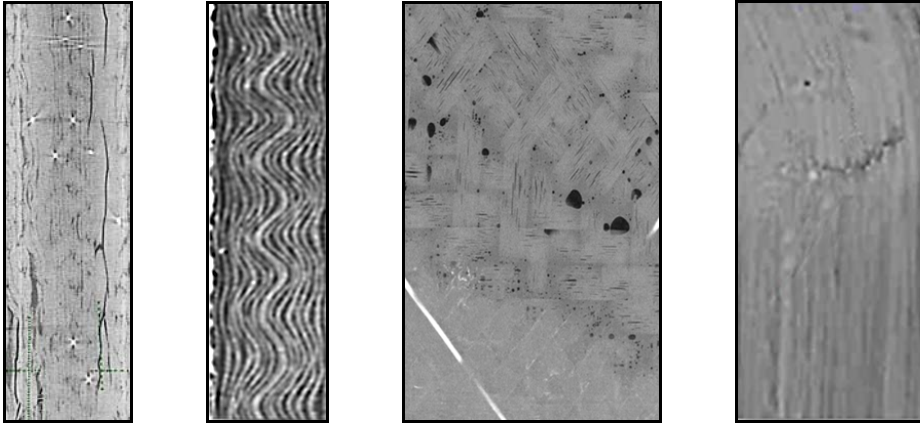
Figure 1: Different kinds of defects in fibre composite materials. From left to right: delamination, undulation, porosity and fibre crack.

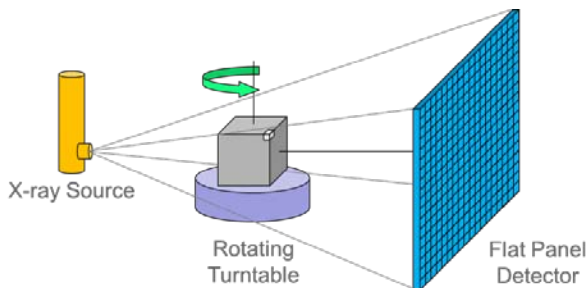
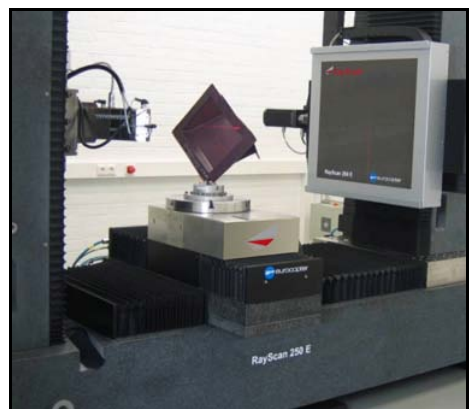
Figure 2: Conventional 3D computed tomography: left: Schematic view, right: CT system RayScan 250 E

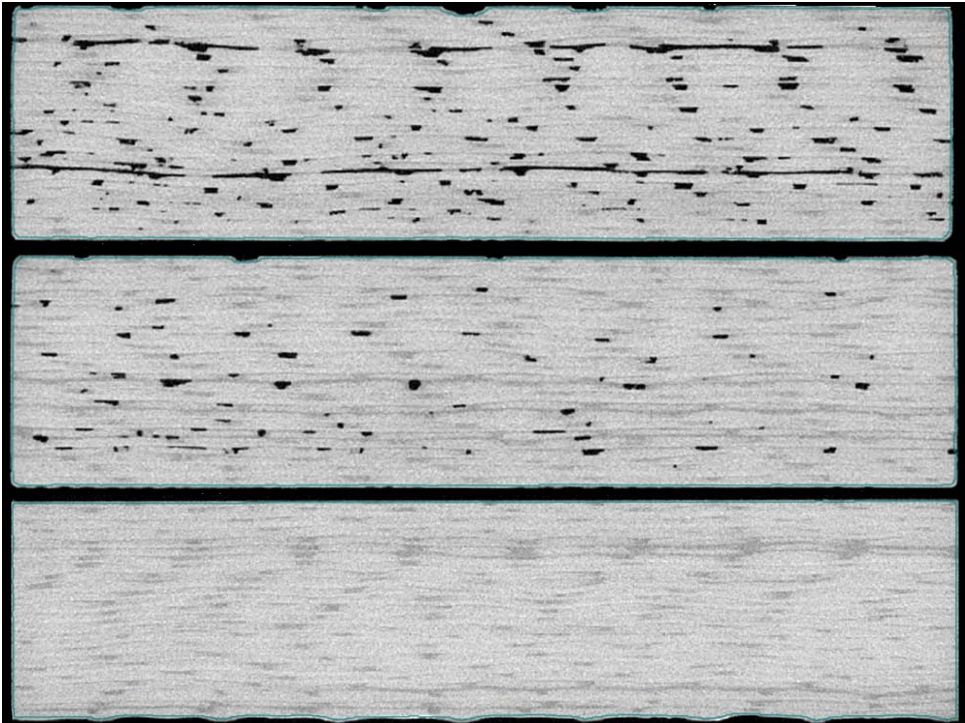
Figure 6: Different samples of a carbon fibre reinforced composites measured with 3D-CT. Porosity values were determined to 5 %, 1.3 % and 0 %.

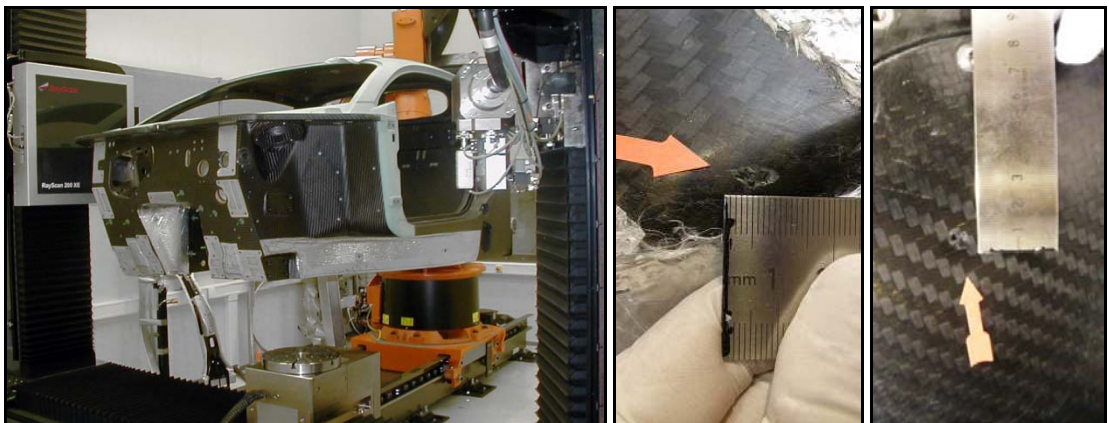
Figure 7: Experimental setup of a measurement of a complete car body made of fibre reinforced composite materials on a RayScan 200 XE CT-System. Left: Placed car body in the measurement field, middle: surface damage caused by a scratch, right: surface damage caused by an impact.

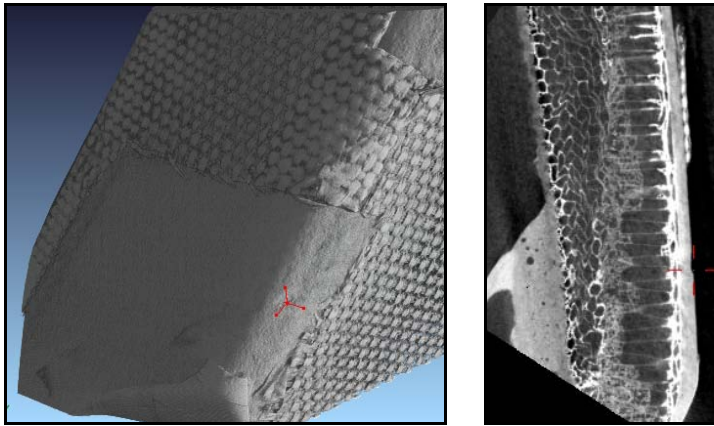
Figure 8: Results of the CT measurement of a part of a complete car body made of fibre reinforced material. Left: 3D visualization of the region under investigation, right: cross sectional slice of the damaged region.

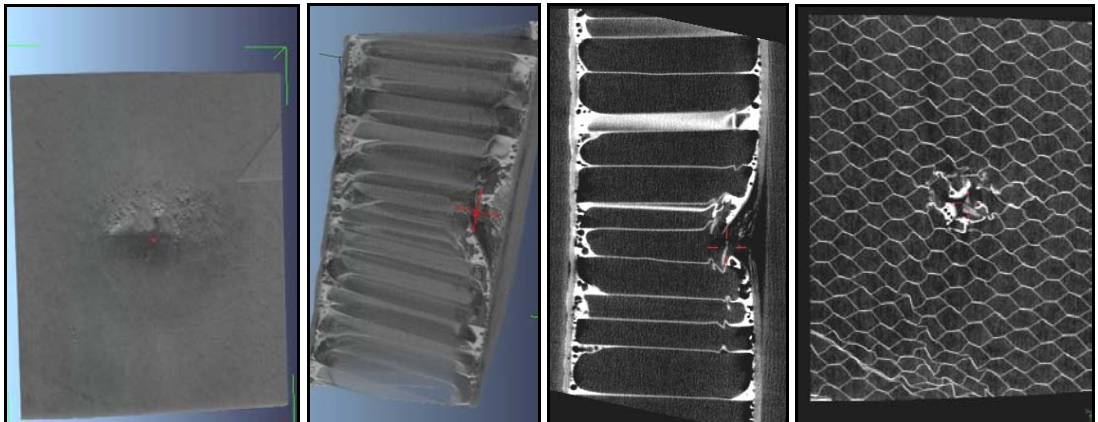
Figure 9: Results of the CT measurement of a part of a complete car body made of fibre reinforced material. Left most images: 3D visualization of the region under investigation, right most images: cross sectional slices of the damaged region.

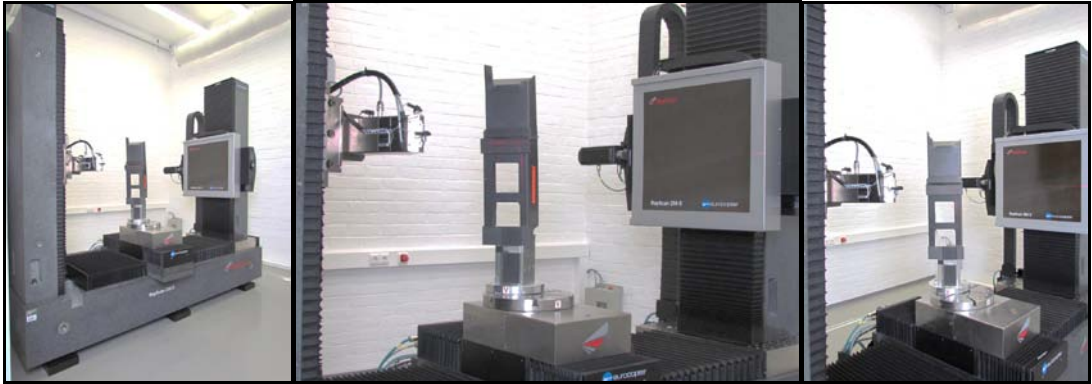
Figure 10: Different views on an experimental setup of a measurement of a carbon fibre reinforced composite part on a RayScan 250 E CT-System.

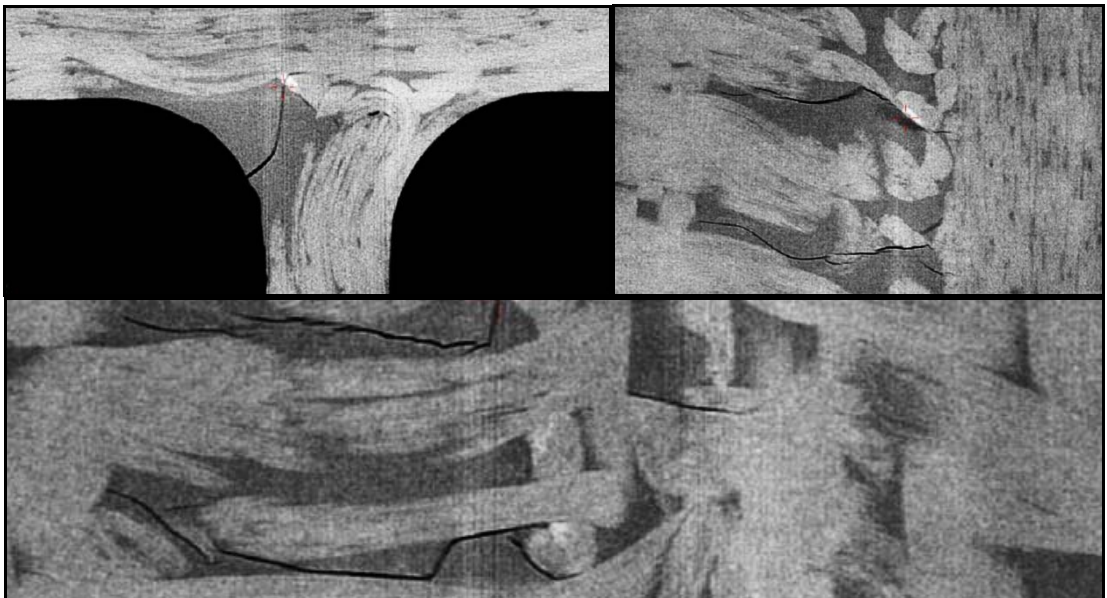
Figure 11: Different views on a CT image of a carbon fibre reinforced composite part. Several cracks can be found near the surface caused by a resin inclusion. Top left: XY-slice, top right: YZ-slice, bottom: zoomed XZ slice.
